MEMORANDUM

SUBJECT: Central Pavilion Roof

DATE: 7/10/2013

On July 3rd, 2013 with the assistance of Rocky Mathisen, I performed a cursory inspection of the Central Pavilion Roof and note the following:

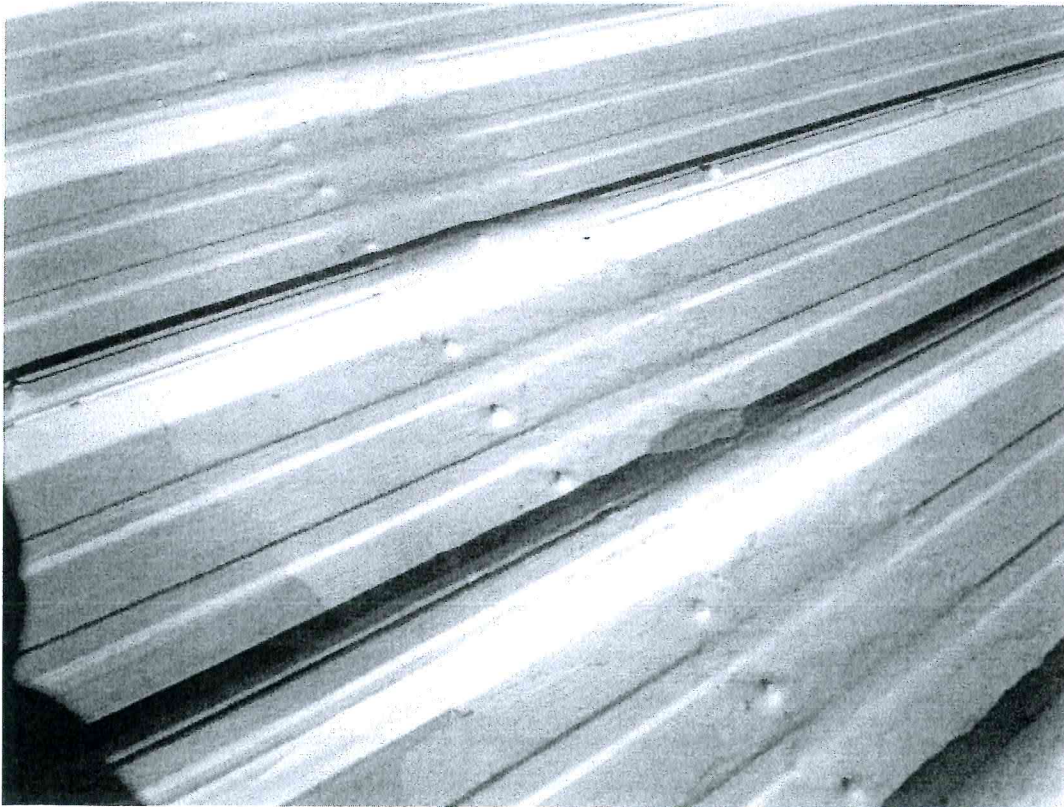
Picture 1

- The roof is a sheet metal roof which has been coated with an elastomeric type of roof coating. (picture 1)
- The screws which attach the metal roofing have been caulked in the past. (picture 2)
- The roof seam located at the mid-point on each side of the roof has a heavier coating of sealer on top of a tar based sealer which is failing. (picture3)
- There are large patches where the roof had been damaged in the past. (pictures 4,5 & 6)
- At the ridge cap the coating has started to flake off of the sponge sealer and the sponge material is starting to deteriorate. (picture 7)
- The metal roofing sheets are still basically sound in that there is no major rusting or movement of the metal.
- There is some rusting occurring around the roof-mounted exhaust fans. (picture 8)

For a short term repair another layer of an elastomeric coating and sealing around the exhaust fans would take care of the leaks.

For a 15 plus year fix the roof is a good candidate for an EPDM overlay. The area between the ribs of the metal roof would be in-filled with a rigid insulation to make a level substrate. On top of the ribs and the insulation would be another layer of insulation and either OSB sheathing or a dense-dek material. To this layer and the metal roof would be a mechanically adhered EPDM roofing material. (see sketch)

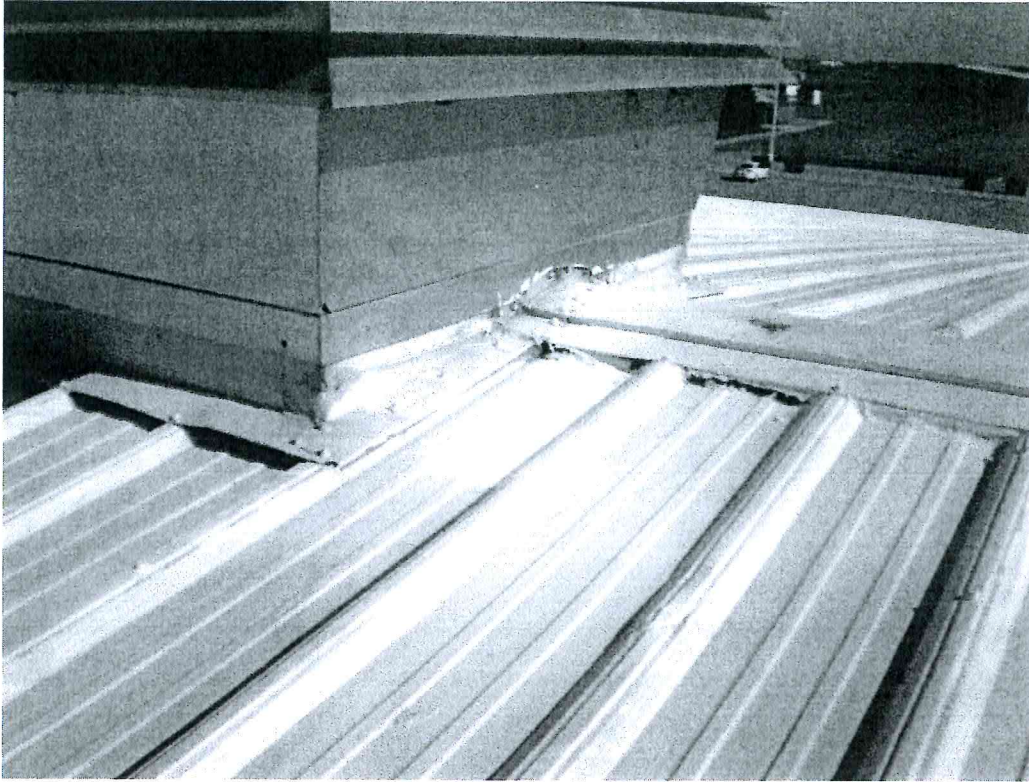
Picture 8

In discussions with Cam-Plex staff the roof mounted exhaust fans are not all being used at the same time and when being used they are drawing the heat or cooling from the building. When used usually only every other one is used. They are also the culprits that have caused the damage to the roof resulting in the large patches. These could be replaced with wall mounted fans and the roof penetrations sealed.
